# **DISTRICT INFRASTRUCTURE ASSESSMENT REPORT**

## **MIDTOWN IMPROVEMENT DISTRICT**

**APRIL 30, 2026**

**McINTOSH ASSOCIATES, an LJA COMPANY  
1950 SUMMIT PARK DRIVE  
ORLANDO, FL 32810**

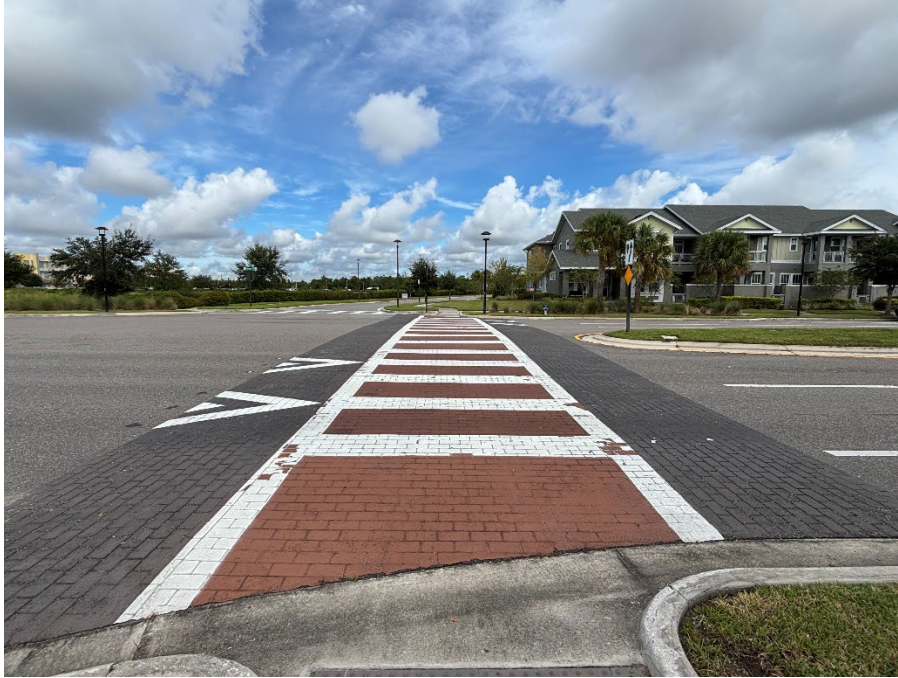
**Photo 1**  
**Deteriorating Thermoplastic and Worn Coloration (No Observed Changes)**  
**(Refer to Prior Photo 1 – 2025 Assessment)**

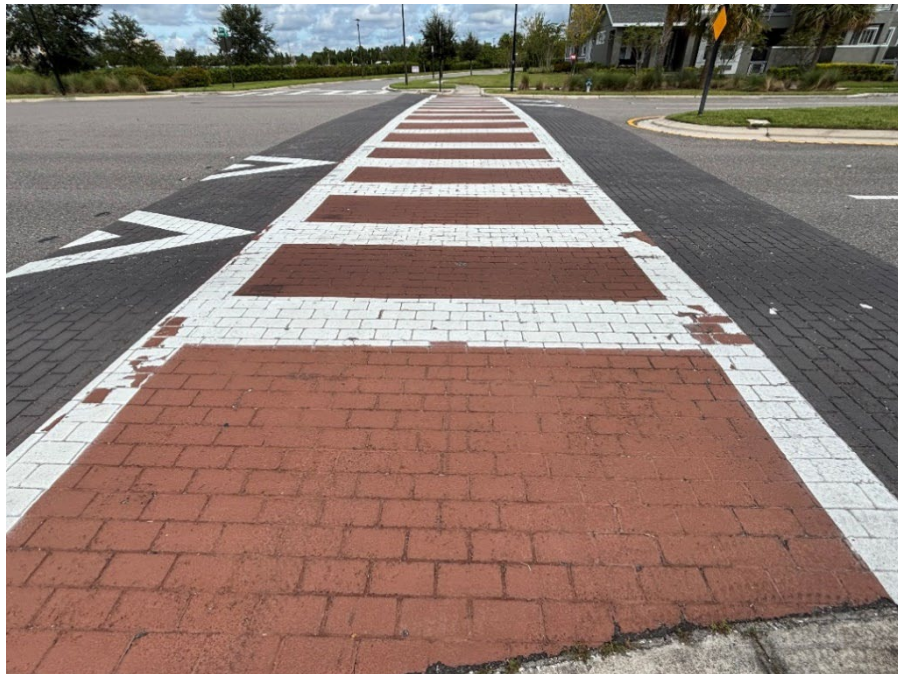
**Photo 2**  
**Deteriorating Thermoplastic and Worn Coloration (No Observed Changes)**  
**(Refer to Prior Photo 2 – 2025 Assessment)**

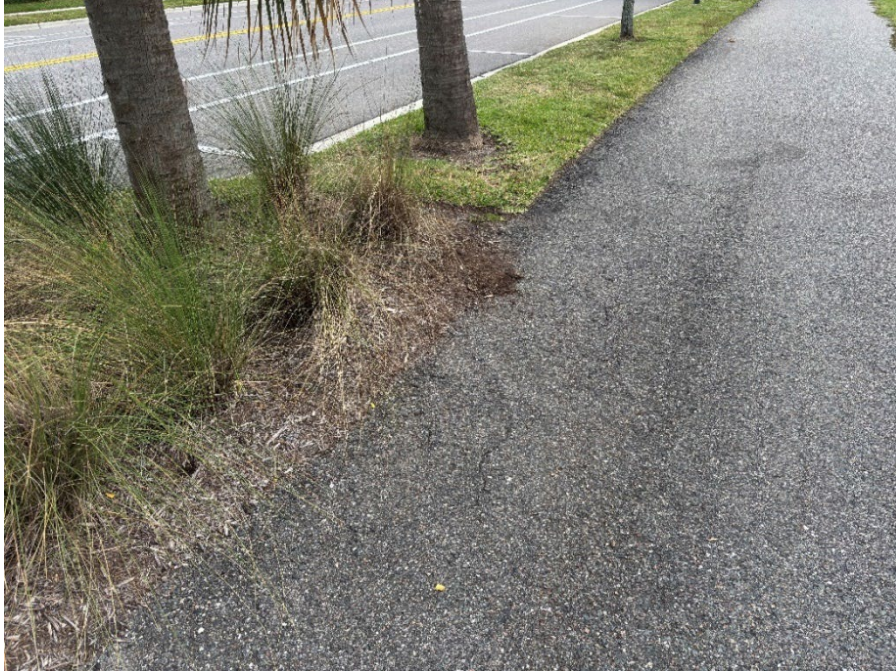
**Photo 3**  
**Asphalt Edge Raveling (Increased Asphalt Raveling Observed)**  
**(Refer to Prior Photo 3 – 2025 Assessment)**

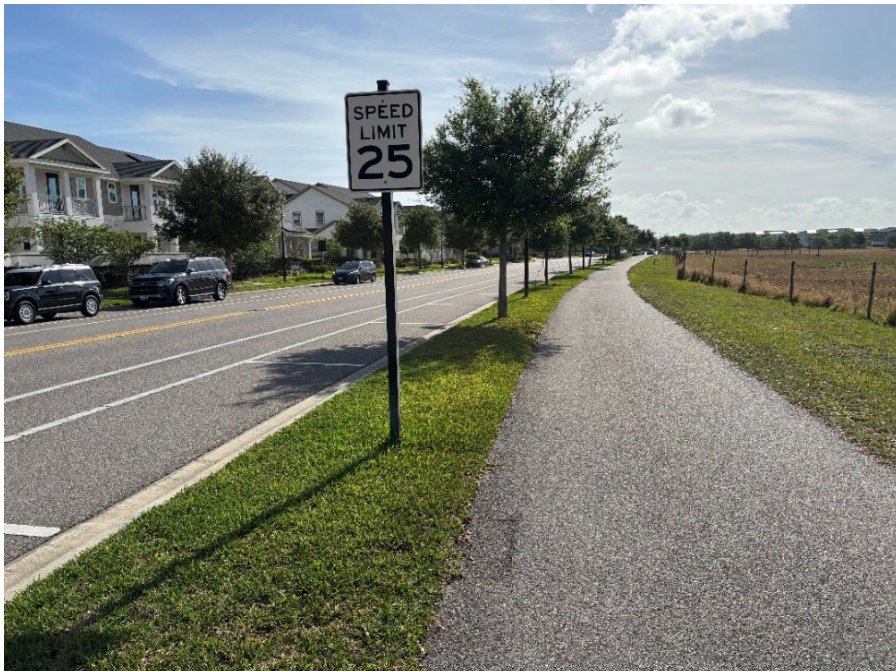
**Photo 3.1 – Uneven Asphalt Patch**  
**(New Photo – 2026 Assessment)**

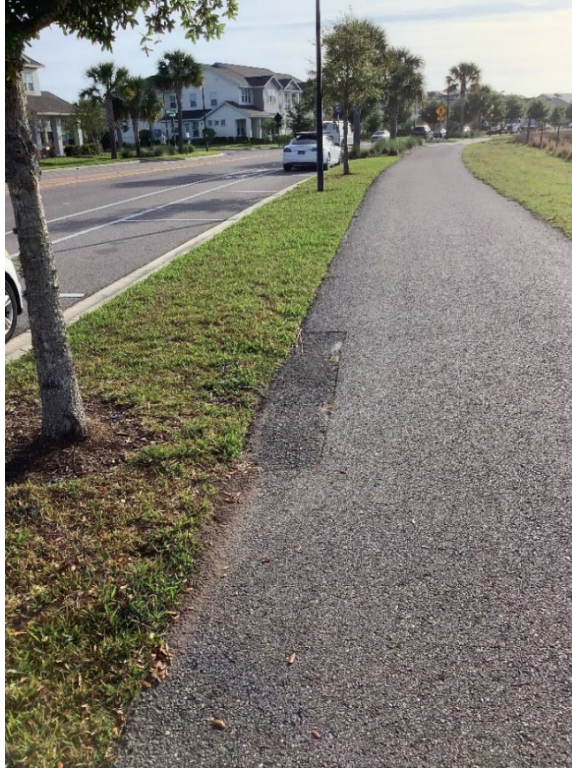
**Photo 4 - Poor Quality Asphalt Patch (No Observed Changes)  
(Refer to Prior Photo 4 – 2025 Assessment)**

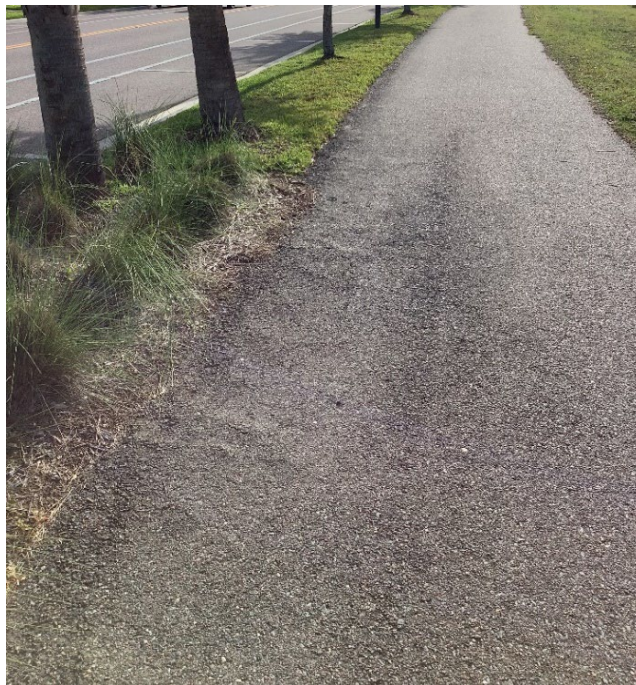
**Photo 5 - Asphalt Raveling (Increased Asphalt Raveling Observed)  
(Refer to Prior Photo 5 – 2025 Assessment)**

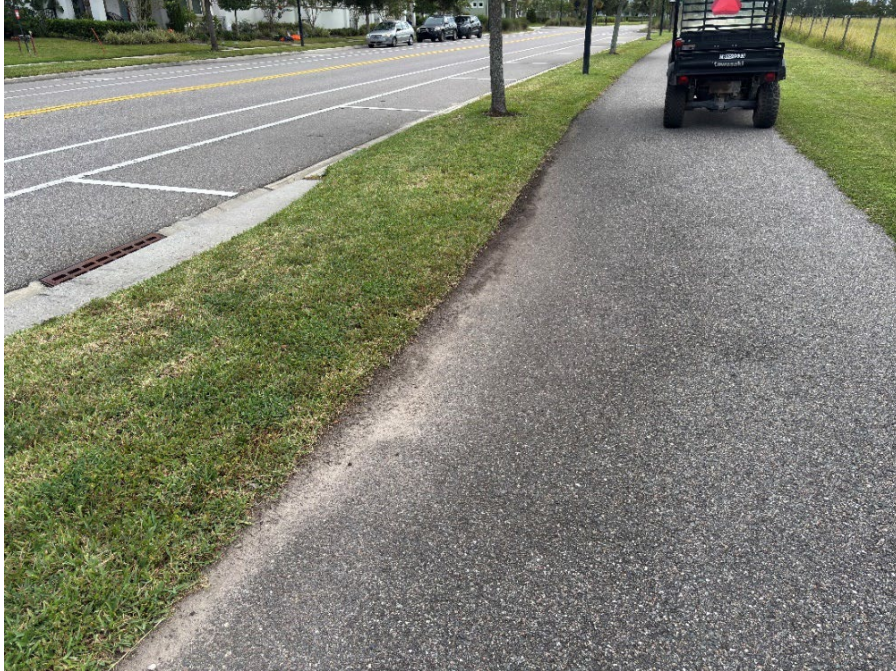
**Photo 6 - Low Area Holding Water (No Observed Changes)  
(Refer to Prior Photo 6 – 2025 Assessment)**

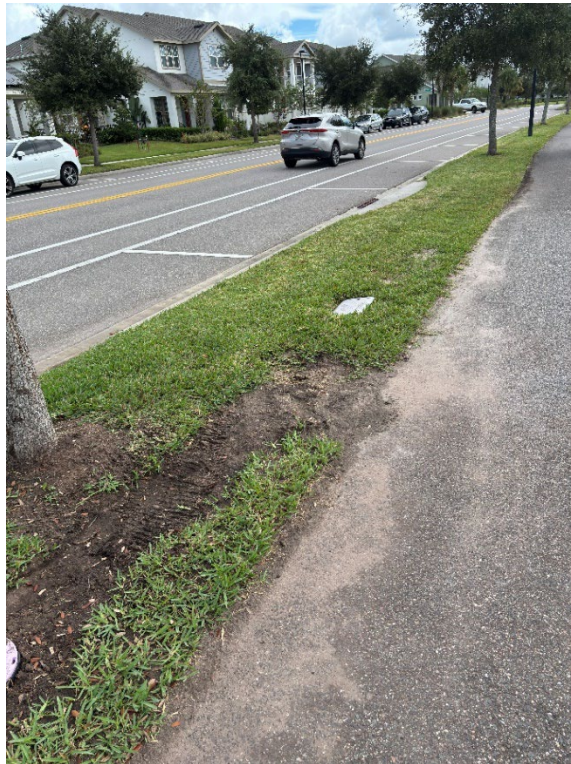
**Photo 7 - Low Area Holding Water (No Observed Changes)  
(Refer to Prior Photo 7 – 2025 Assessment)**

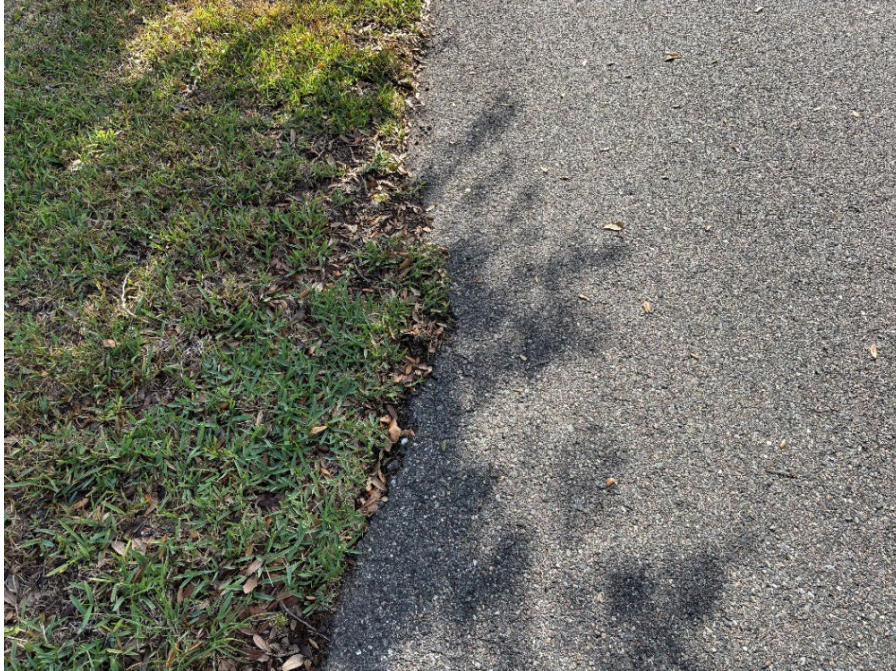
**Photo 7.1 – Asphalt Edge Failure  
(New Photo – 2026 Assessment)**

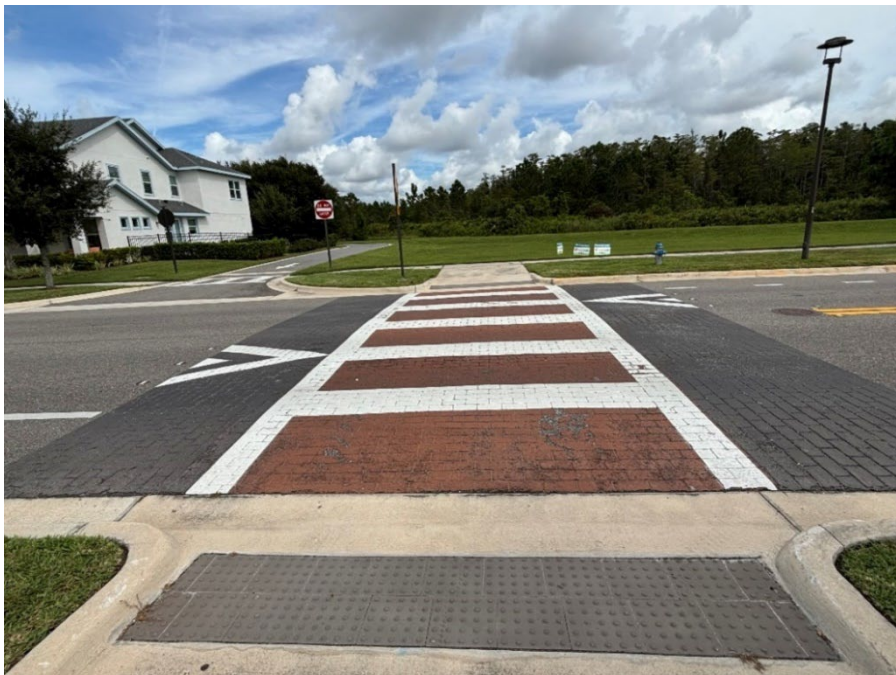
**Photo 8  
Deteriorating Thermoplastic and Worn Coloration (No Observed Changes)  
(Refer to Prior Photo 8 – 2025 Assessment)**

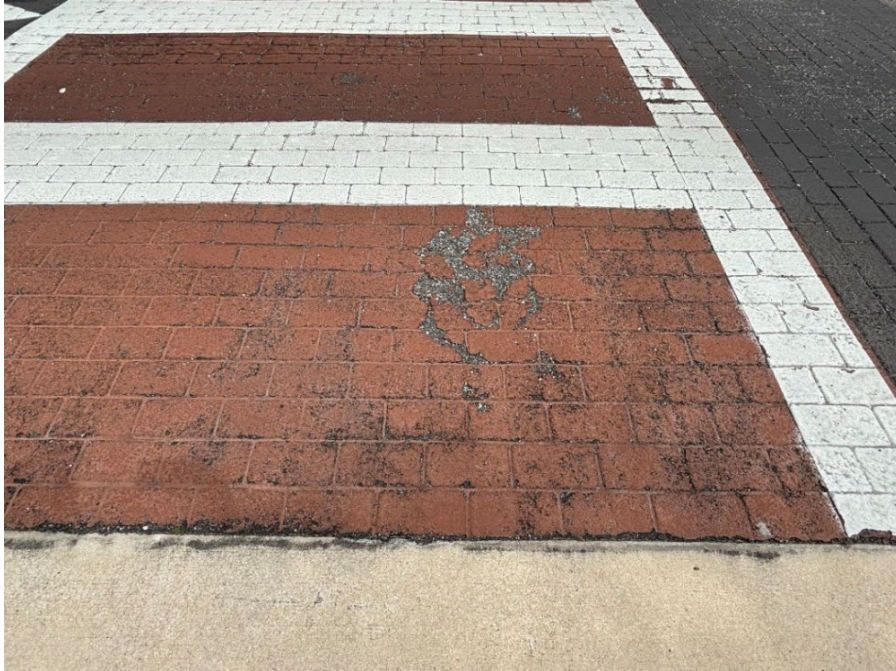
**Photo 9**  
**Deteriorating Thermoplastic and Worn Coloration (No Observed Changes)**  
**(Refer to Prior Photo 9 – 2025 Assessment)**

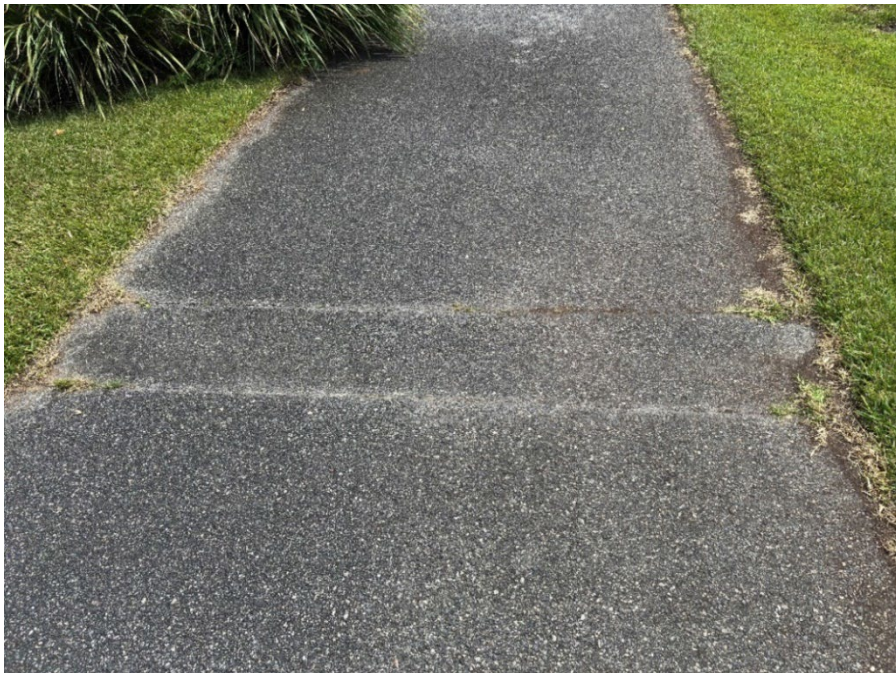
**Photo 10 - Cracked Asphalt from Side to Side (No Observed Changes)**  
**(Refer to Prior Photo 10 – 2025 Assessment)**

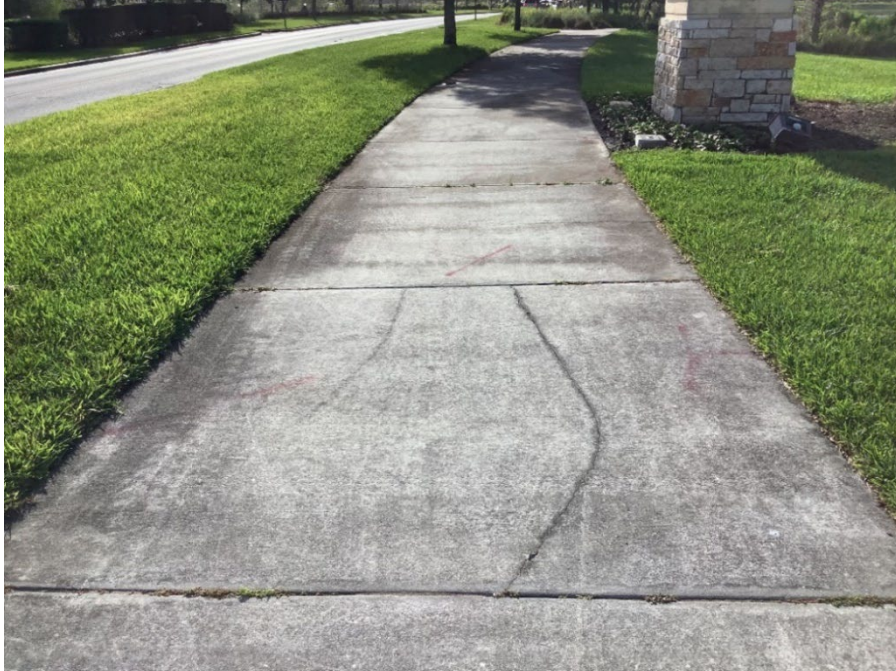
**Photo 11 - Surficial Cracked Concrete (No Observed Changes)  
(Refer to Prior Photo 11 – 2025 Assessment)**

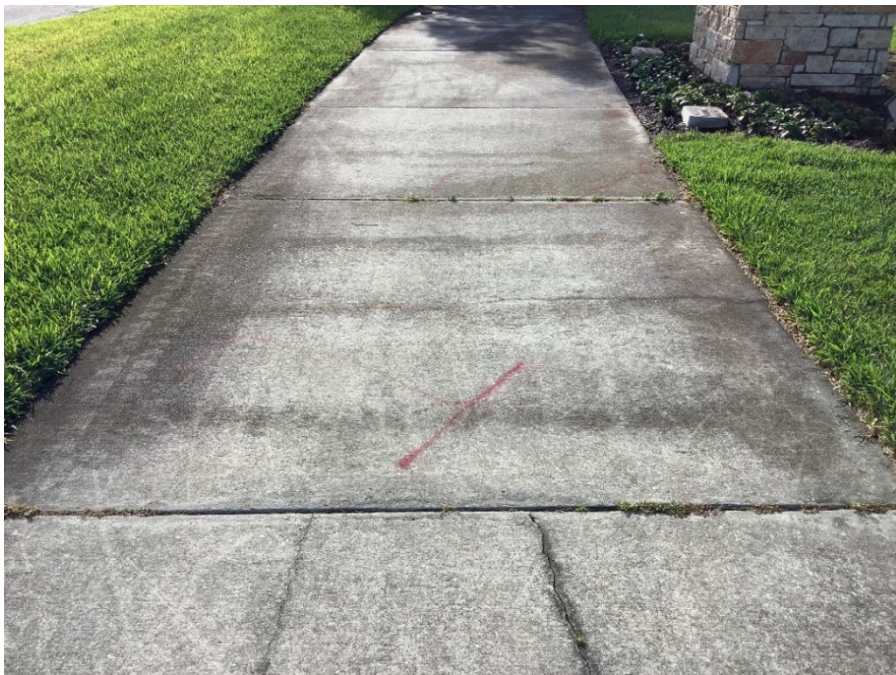
**Photo 12 - Surficial Cracked Concrete (No Observed Changes)  
(Refer to Prior Photo 12 – 2025 Assessment)**

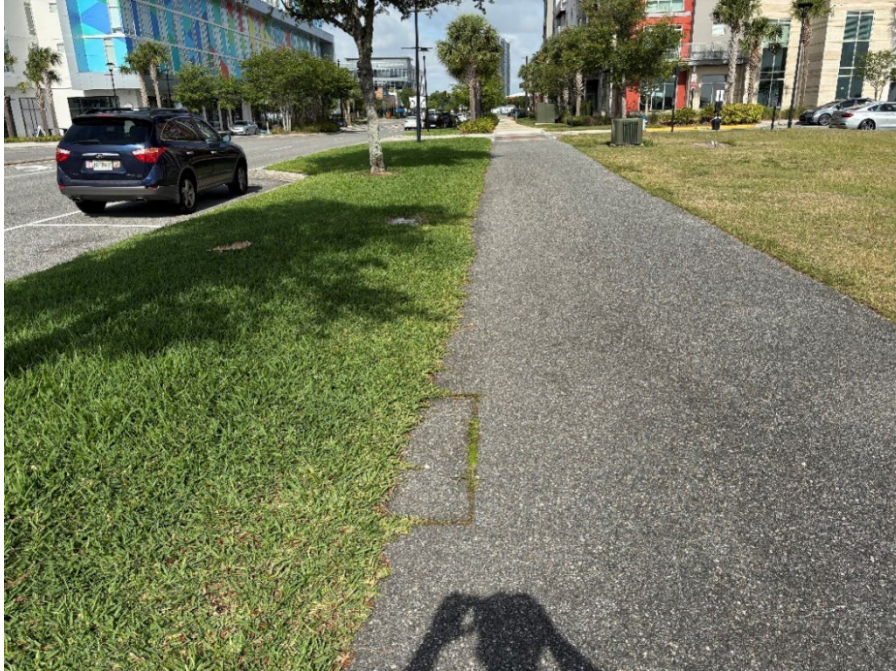
**Photo 12.1 - Poor Quality Asphalt Patch  
(New Photo – 2026 Assessment)**

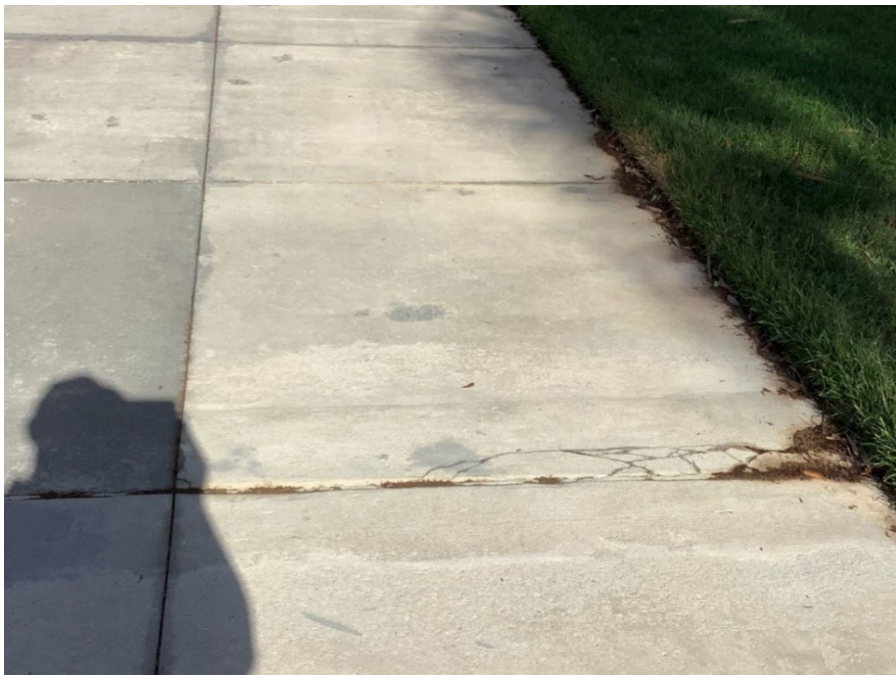
**Photo 13 - Cracked Concrete (No Observed Changes)  
(Refer to Prior Photo 13 – 2025 Assessment)**

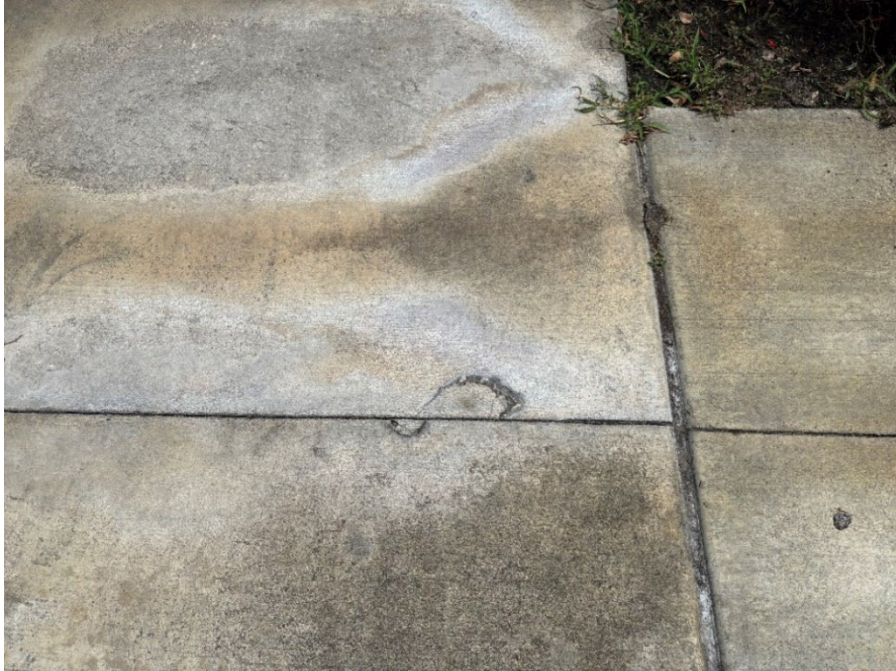
**Photo 14 - Surficial Cracked Concrete (No Observed Changes)  
(Refer to Prior Photo 14 – 2025 Assessment)**

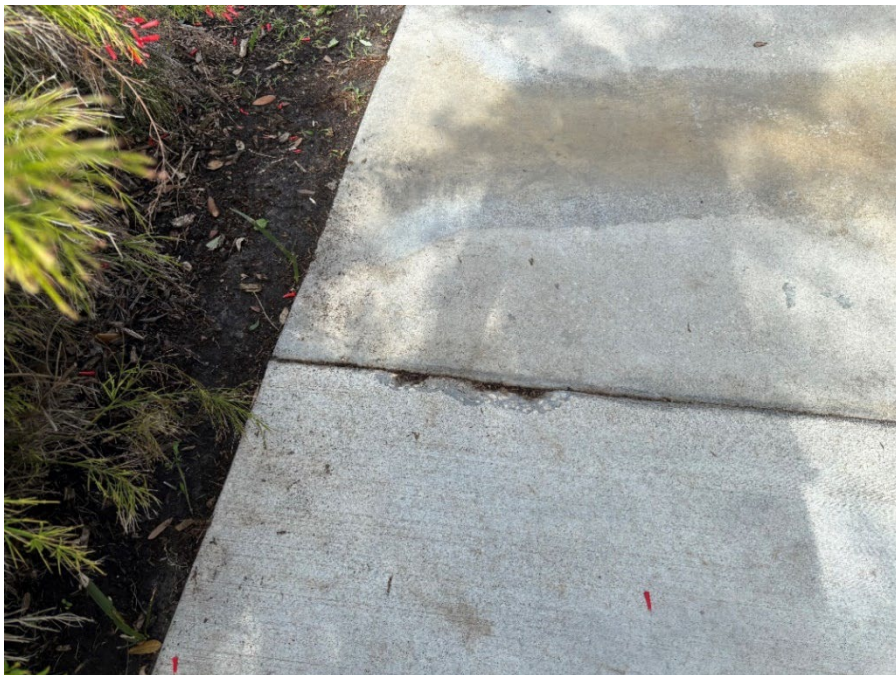
**Photo 15 - Broken Concrete (No Observed Changes)  
(Refer to Prior Photo 15 – 2025 Assessment)**

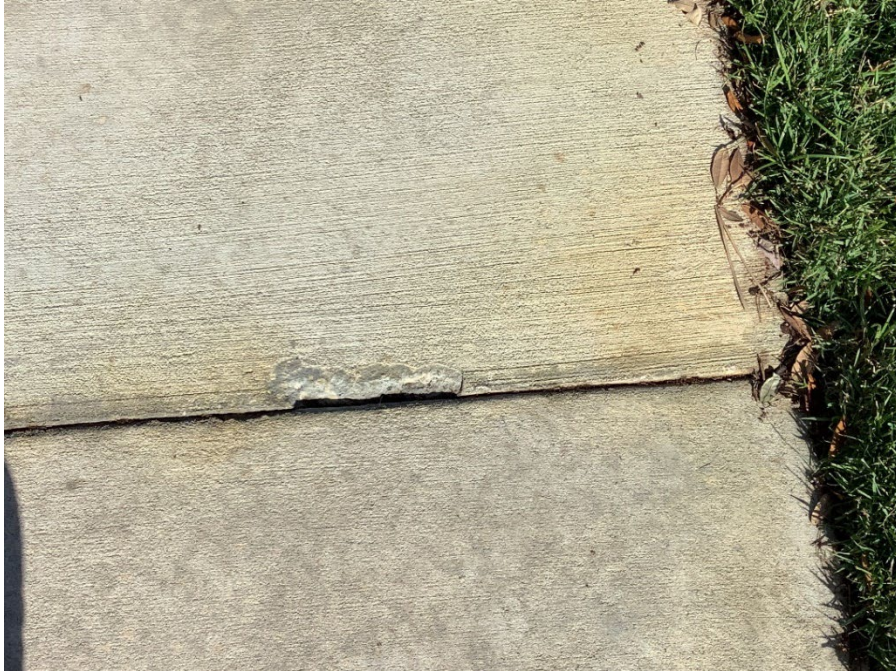
**Photo 15.1 Broken Concrete  
(New Photo – 2026 Assessment)**

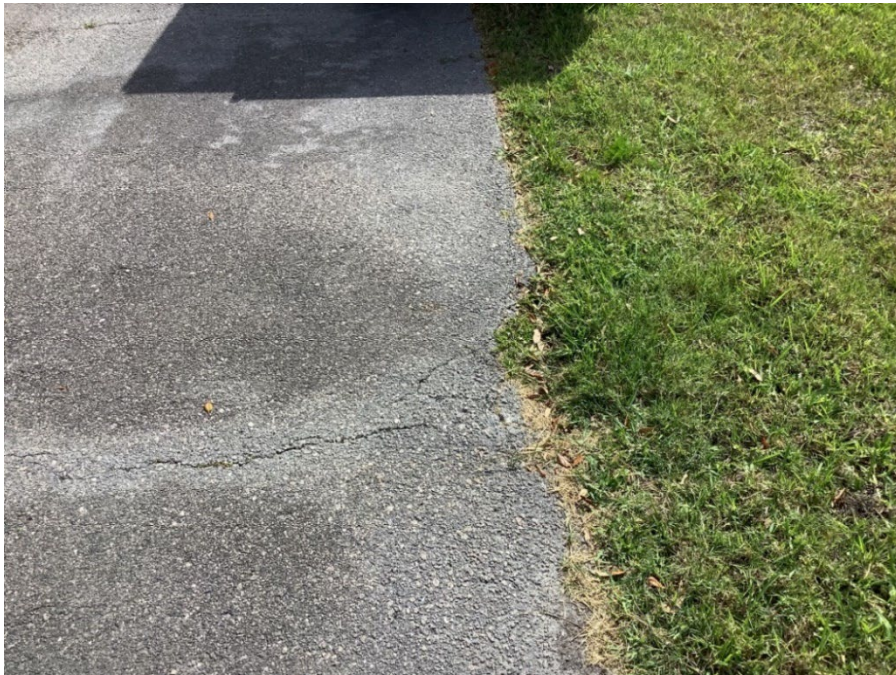
**Photo 16 - Asphalt Raveling and Base Failure  
(Further Edge Failure Observed and Cracked Asphalt from Side to Side)  
(Refer to Prior Photo 17 – 2025 Assessment)**

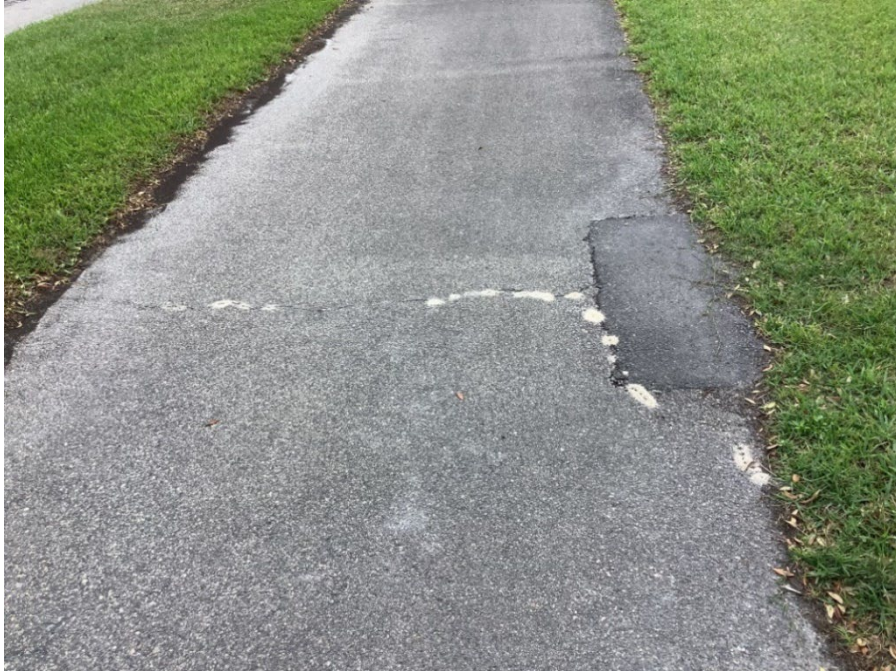
**Photo 17 - Poor Quality Asphalt Patch (No Observed Changes)  
(Refer to Prior Photo 20 – 2025 Assessment)**

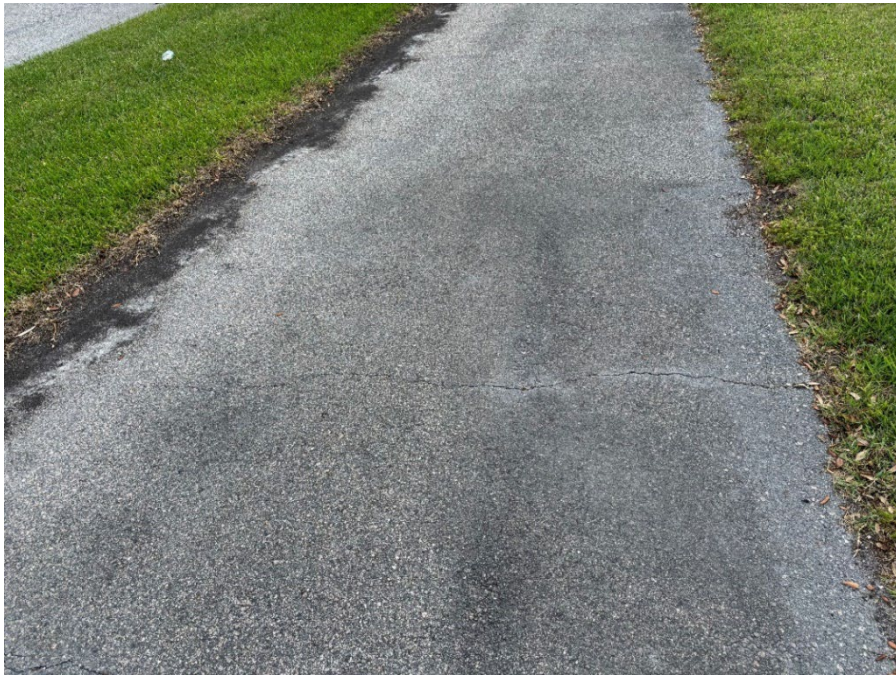
**Photo 17.1 - Cracked Asphalt from Side to Side  
(New Photo – 2026 Assessment)**

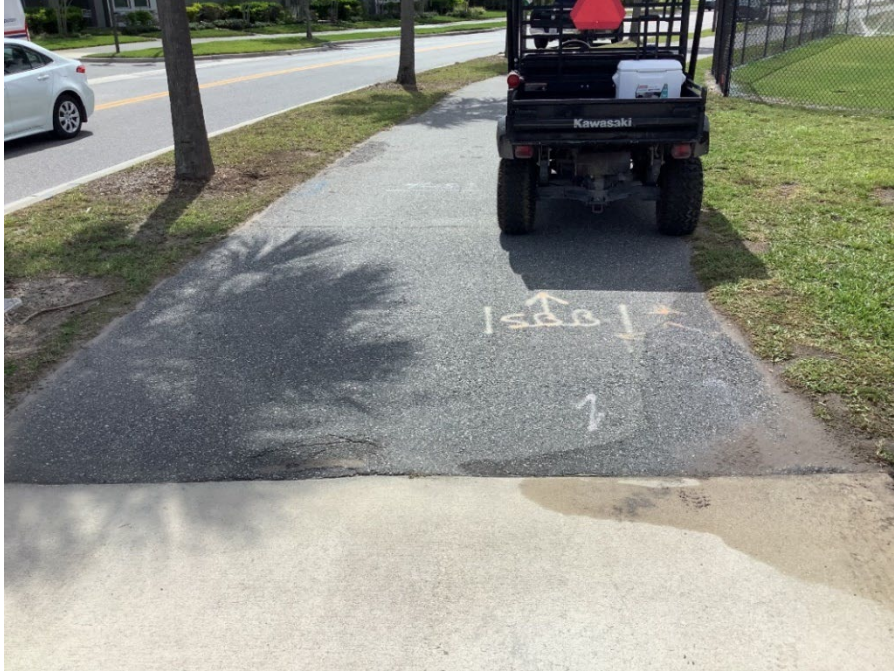
**Photo 18 - Asphalt Raveling and Base Failure (No Observed Changes)  
(Refer to Prior Photo 22 – 2025 Assessment)**

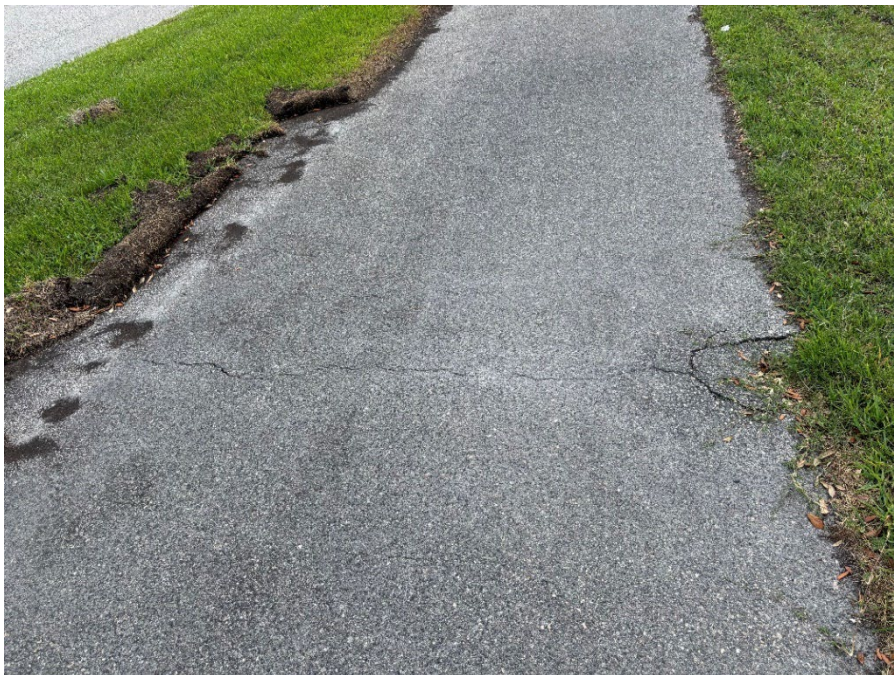
**Photo 18.1 - Asphalt Raveling and Base Failure, Cracked Asphalt from Side to Side  
(New Photo – 2026 Assessment)**

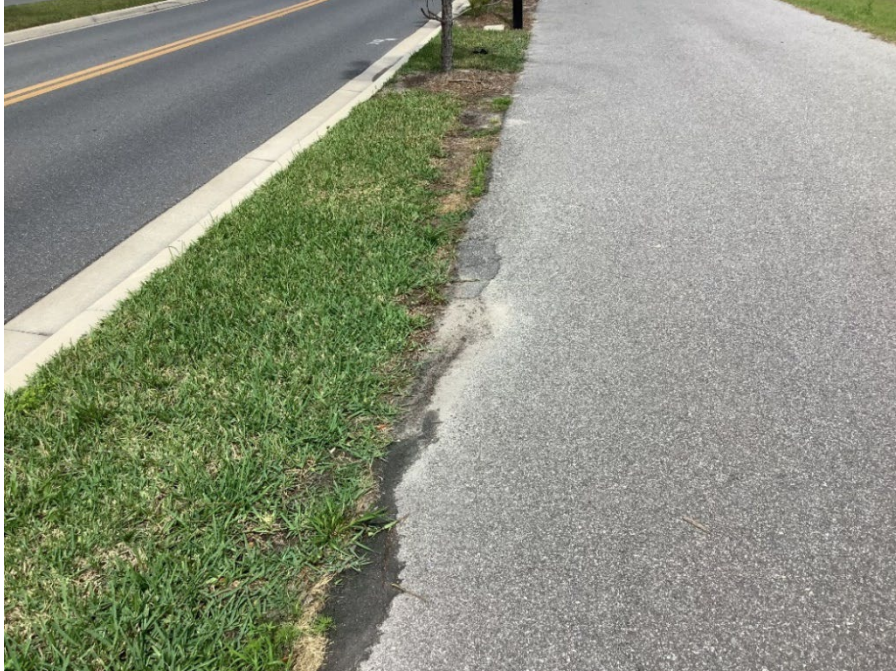
**Photo 19 - Asphalt Raveling and Base Failure (No Observed Changes)  
(Refer to Prior Photo 24 – 2025 Assessment)**

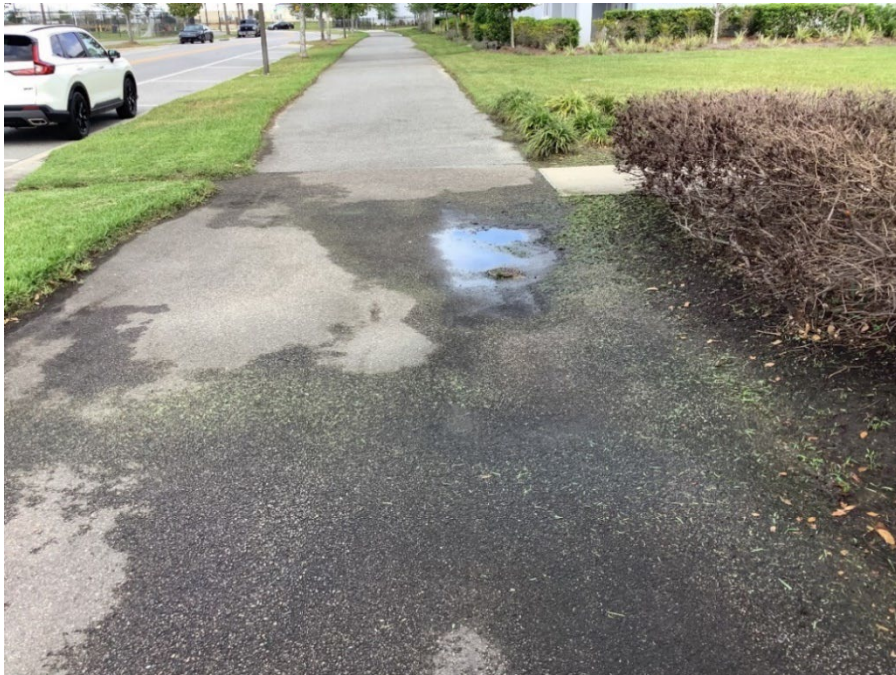
**Photo 19.1 - Low Area Holding Water, Asphalt Raveling and Base Failure  
(New Photo – 2026 Assessment)**

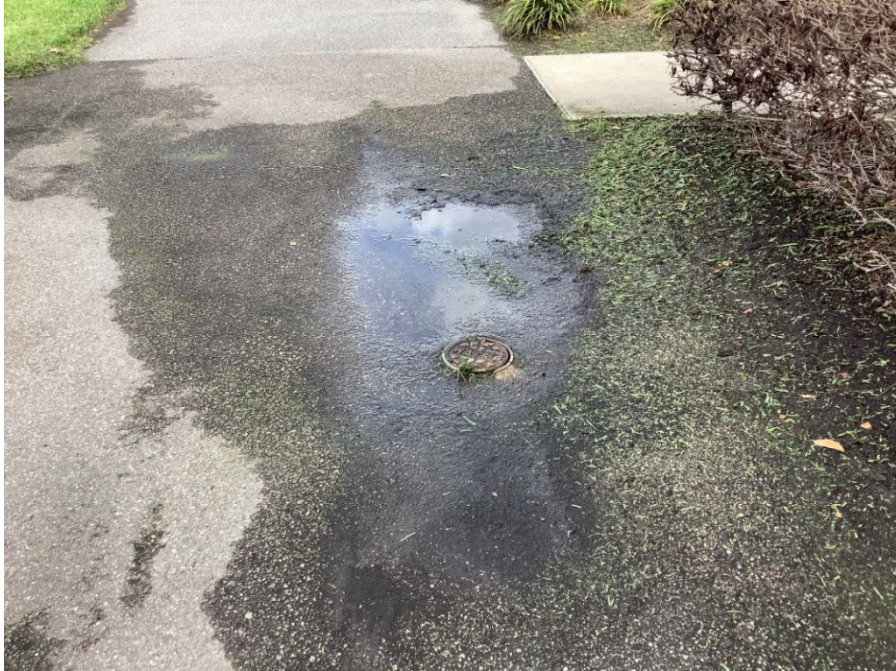
**Photo 20 – Valve Cover Reveal ½ -inch  
(Low Area Holding Water, Asphalt Raveling and Base Failure)  
(Refer to Prior Photo 26 – 2025 Assessment)**

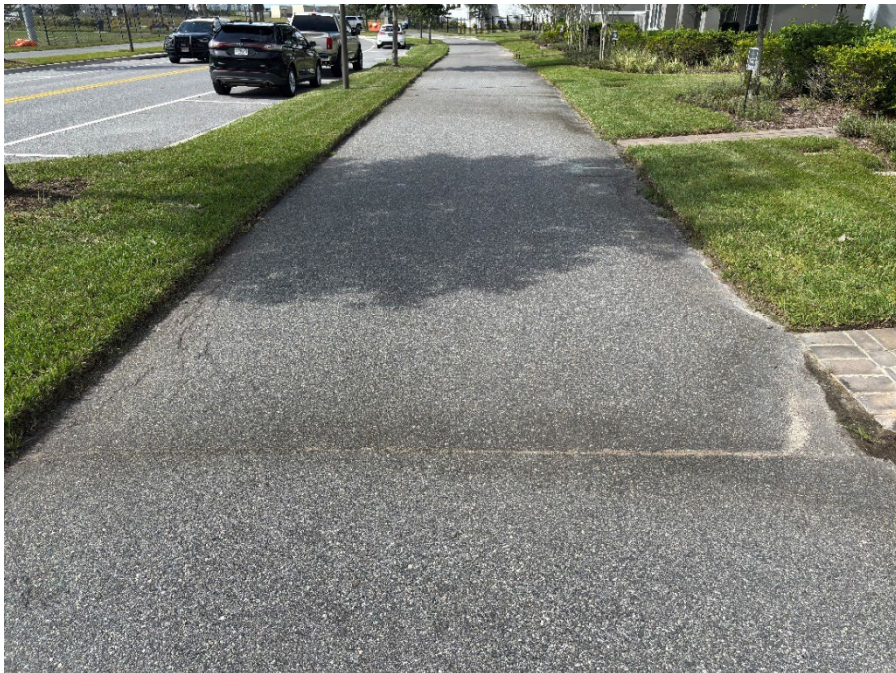
**Photo 21 - Cracked Asphalt from Side to Side (No Observed Changes)  
(Refer to Prior Photo 28 – 2025 Assessment)**

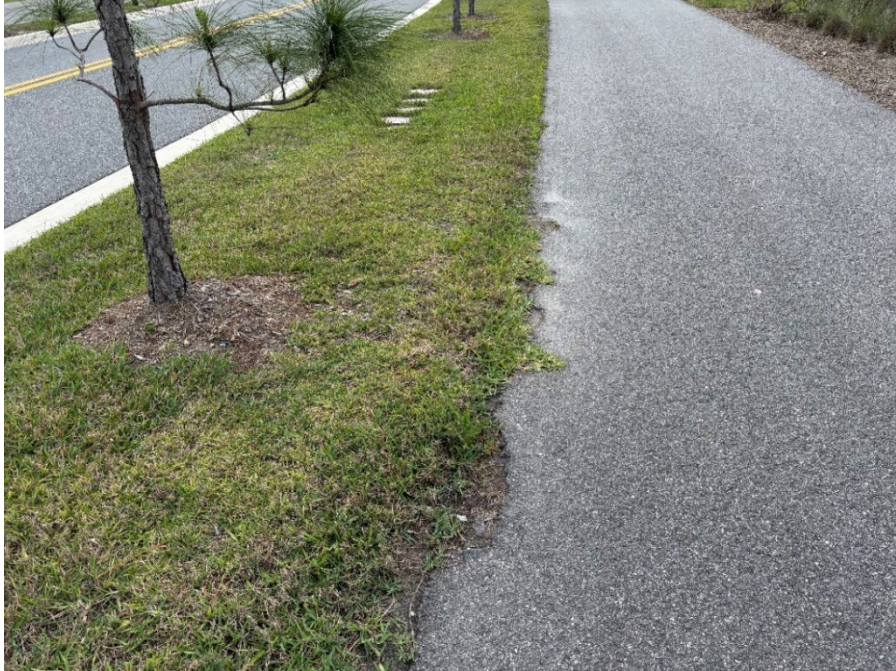
**Photo 21.1 - Asphalt Edge Failure  
(New Photo – 2026 Assessment)**

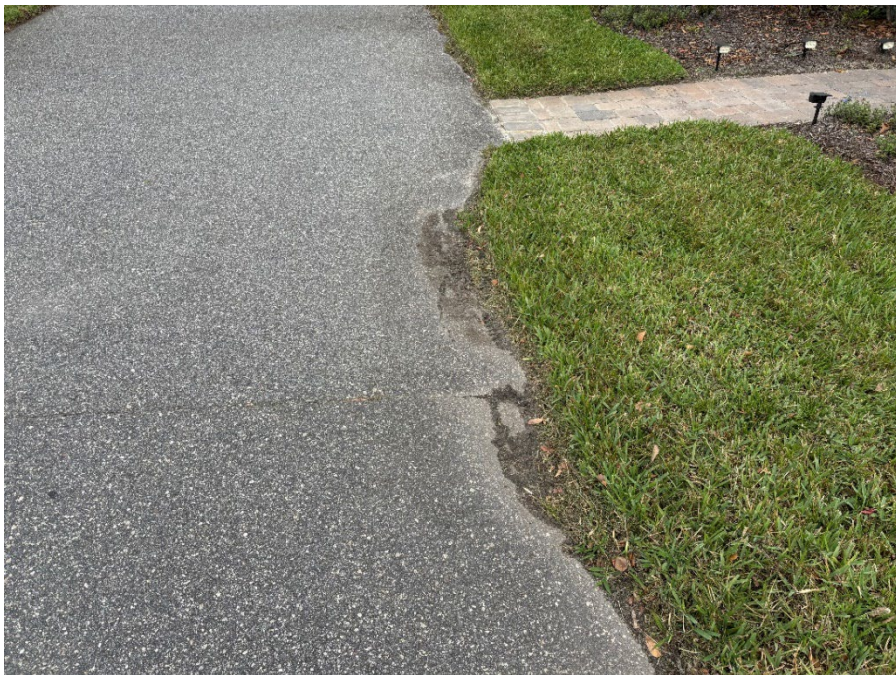
**Photo 22 - Asphalt Raveling and Base Failure (No Observed Changes)  
(Refer to Prior Photo 29 – 2025 Assessment)**
